X-Ray Evaluation of the Above Knee Socket;
A Supplement to Standard Check-out Procedures

Capt. C. James Scanlon, AMSC
Lt. Col. Bob Doctor, AMSC

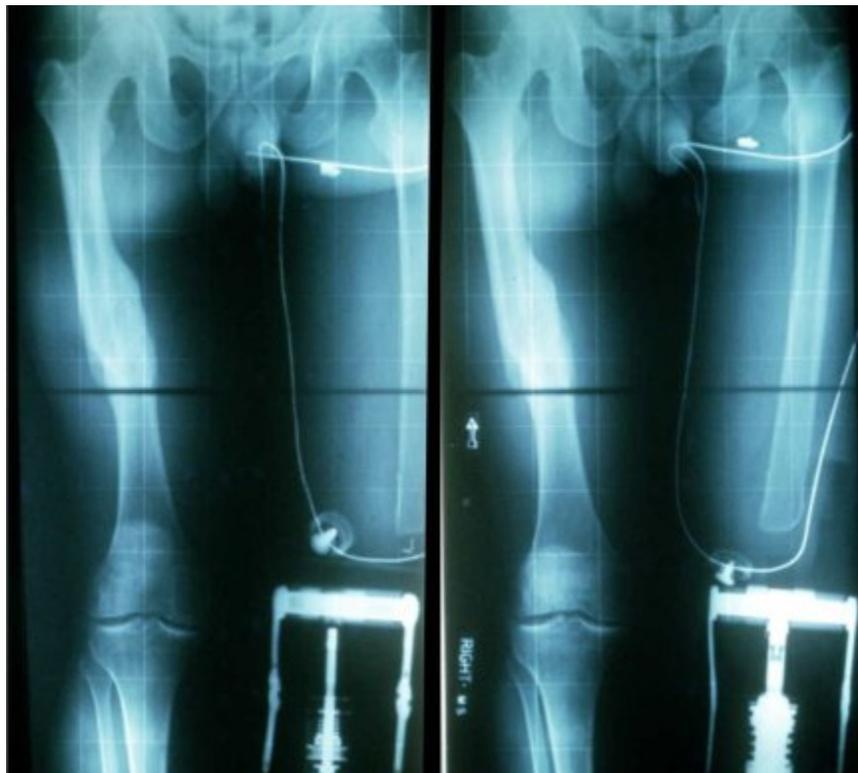
Figure 3

1. Hip Adduction Angle. Ninety-eight percent of the x-rays of a group of amputees who had previously been fitted with the standard above-knee prosthesis demonstrated less than an equal femoral adduction angle on the amputated side and sixty-eight percent of the stumps were in absolute abduction. This deviation from the intended biomechanical optimum was the most common deviation found and nearly impossible to detect by any means other than x-ray examination. Clinically, all did have a significant gluteus medius (compensated Trendelenburg) gait. Figure (3) shows the typical abducted posture of the femur noted on x-ray evaluation as well as the more ideal posture where the femoral adduction angles are equal. Based upon this study we found that very few of the prostheses built according to standard alignment criteria achieve the desired hip adduction posture and that the actual degree of adduction of the femur

within the socket cannot be determined by the angle of the lateral wall of the prosthesis itself.

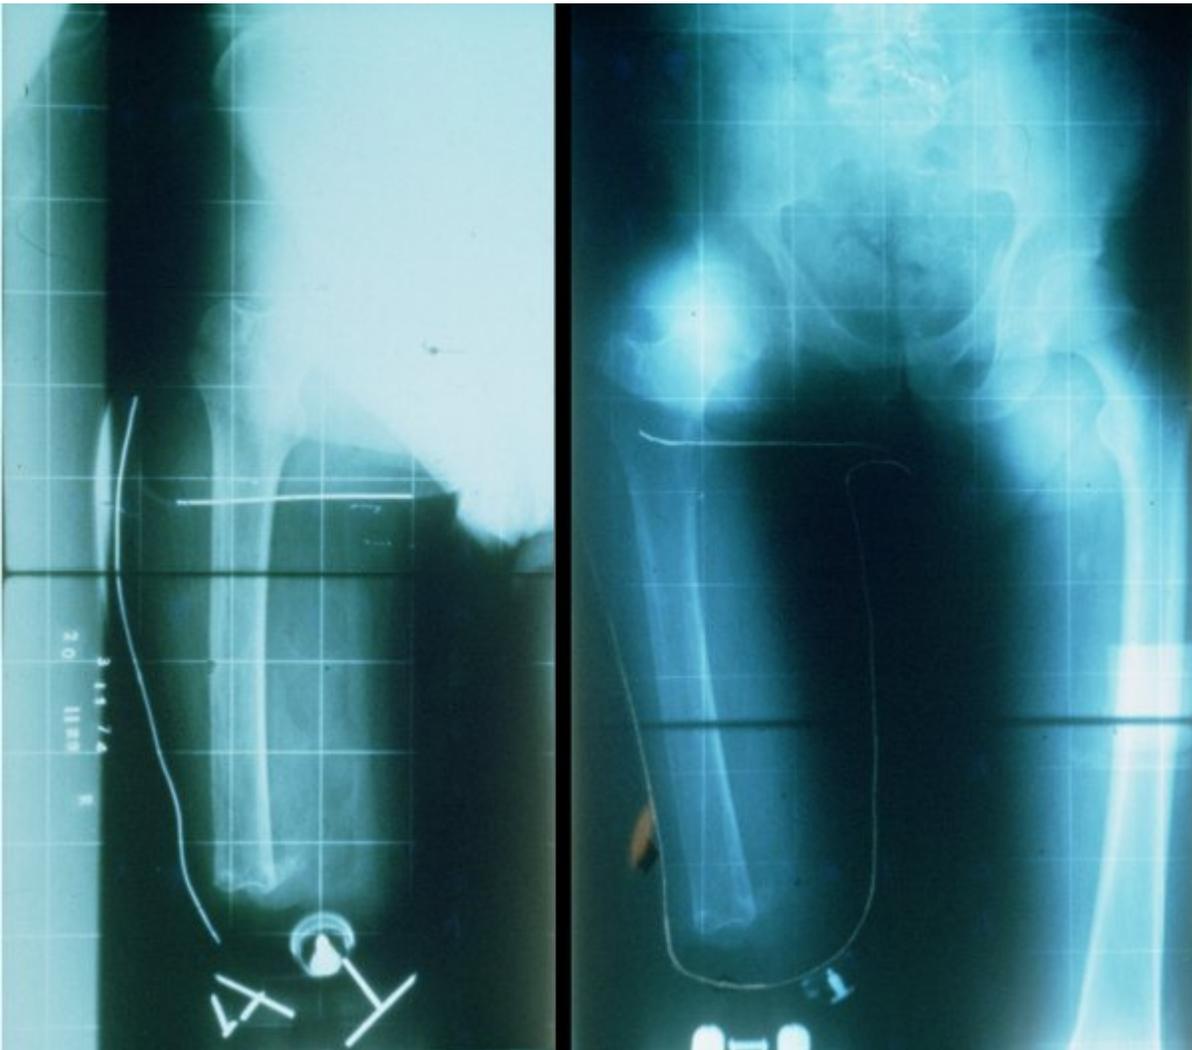
Figure 4

2. Lateral Wall Support. Lack of adequate support as well as unequal distribution of weight along the lateral wall of the prosthesis was another point easily discernible via x-ray and not so by other means. Figure (4) depicts a bulging lateral wall offering little lateral support and a better fitting prosthesis that provides good lateral stability and equal weight distribution.

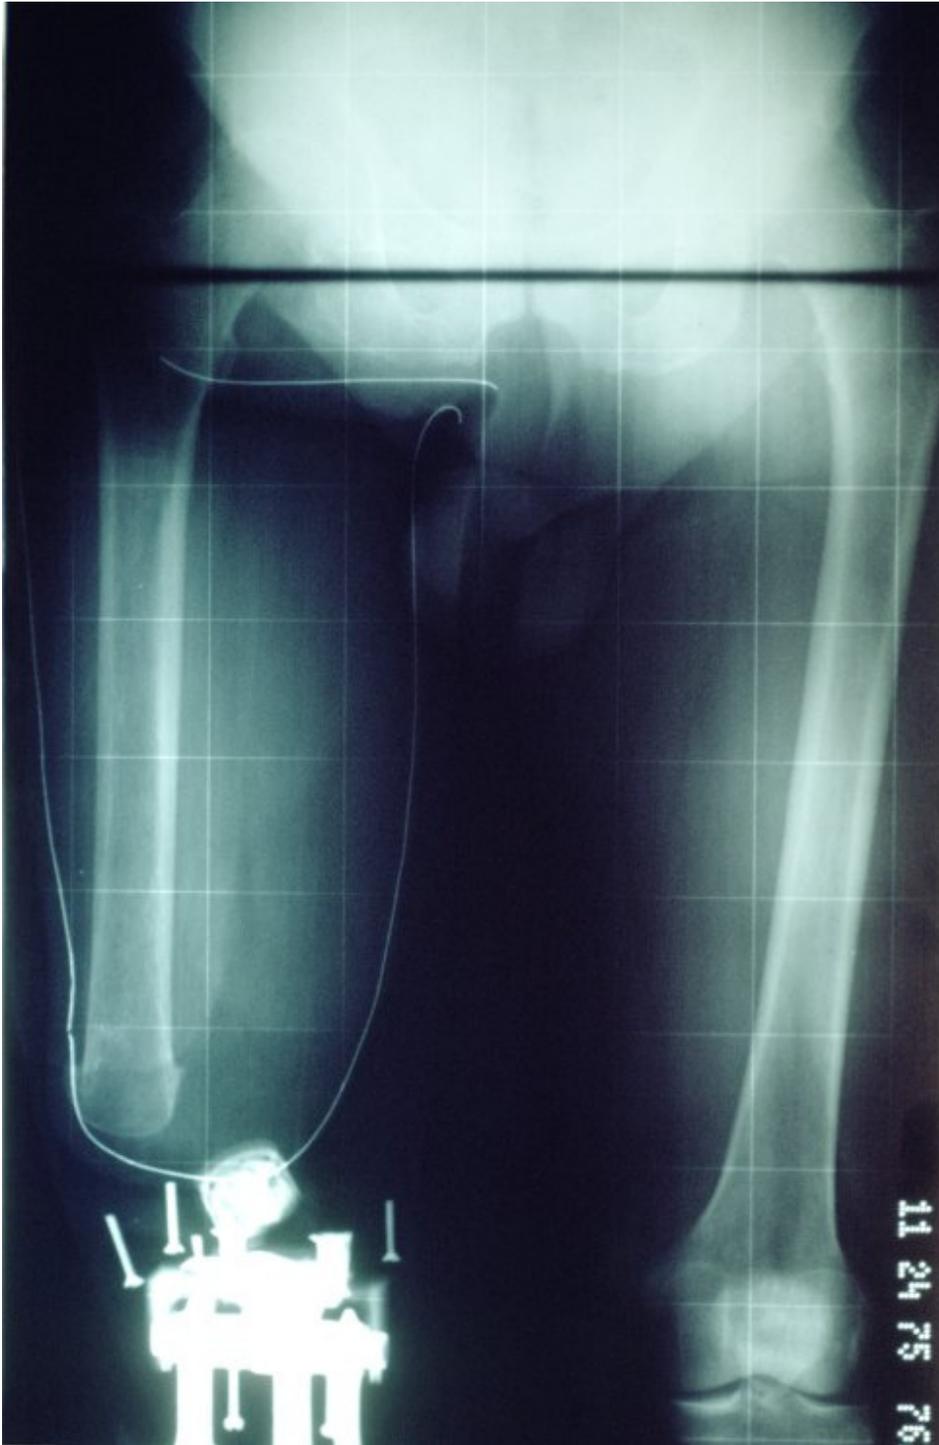
Figure 5

3. Pressure Points. Figure (5) demonstrates how readily pressure points at the distal stump can be diagnosed thru the use of an x-ray. This patients' antalgic gait was relieved by correcting this mal-alignment.

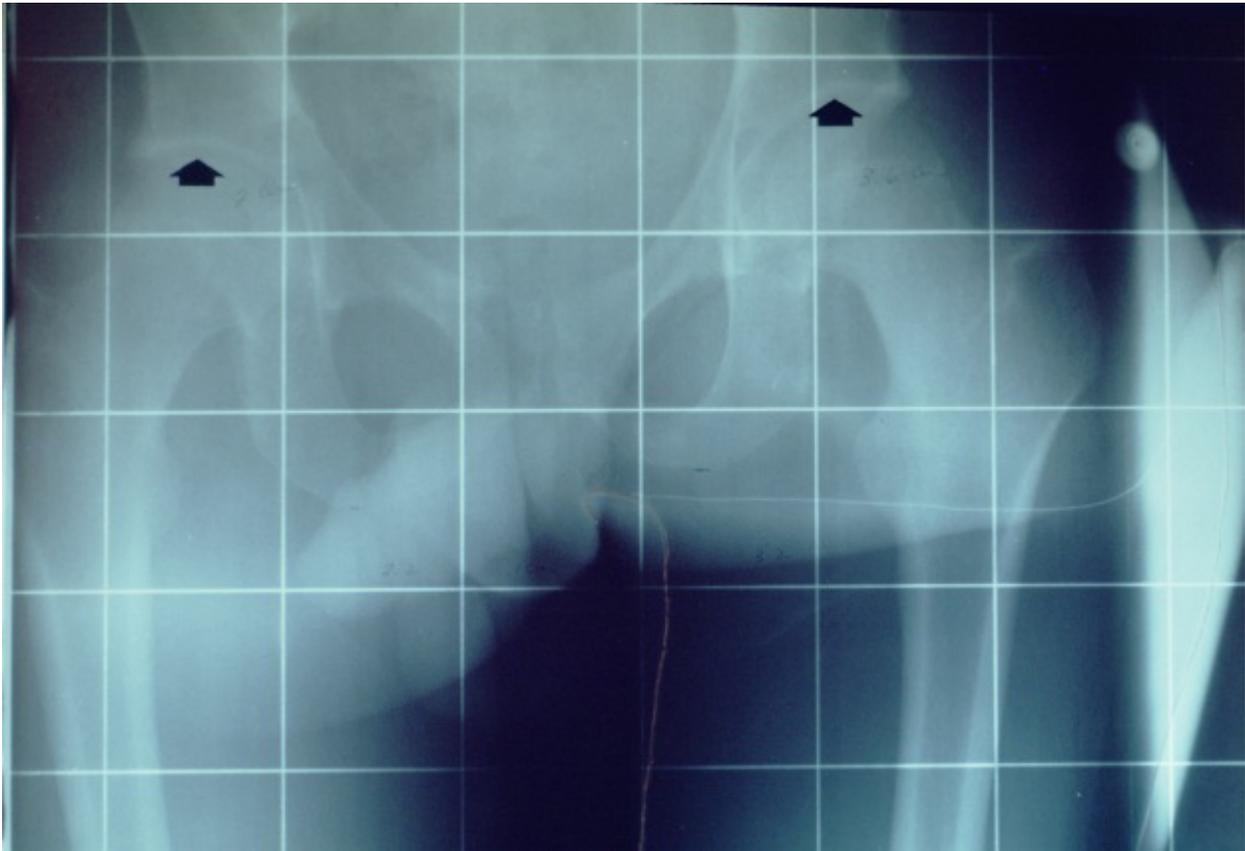
Figure 6

4. Leg Length Discrepancy. Utilizing such boney landmarks as the heads of the femur or the iliac crests aids in detecting leg length discrepancies provided you are assured the patient is bearing weight equally on both legs at the time of the x-ray exam. The grid lines in figure (6) are horizontal to the floor - Note the height difference at the femoral heads.

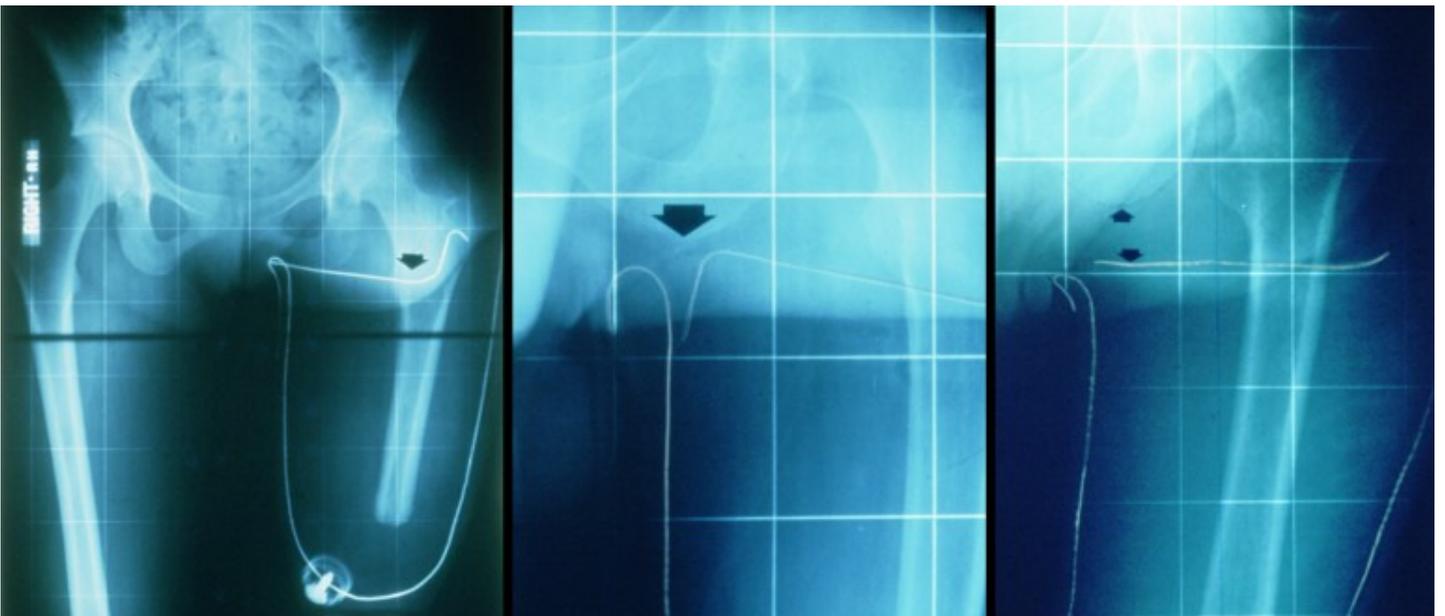
Figure 8

5. Ischial Seat. The actual position of the Ischial tuberosity on the posterior brim of the prosthesis is yet another difficult point to pin point clinically. The usual standard is for the tuberosity of the ischium to rest directly on a level posterior brim approximately one inch from the medial wall as noted in Figure (7). Figure (8) shows a variety of different deviations found thru x-ray examination.

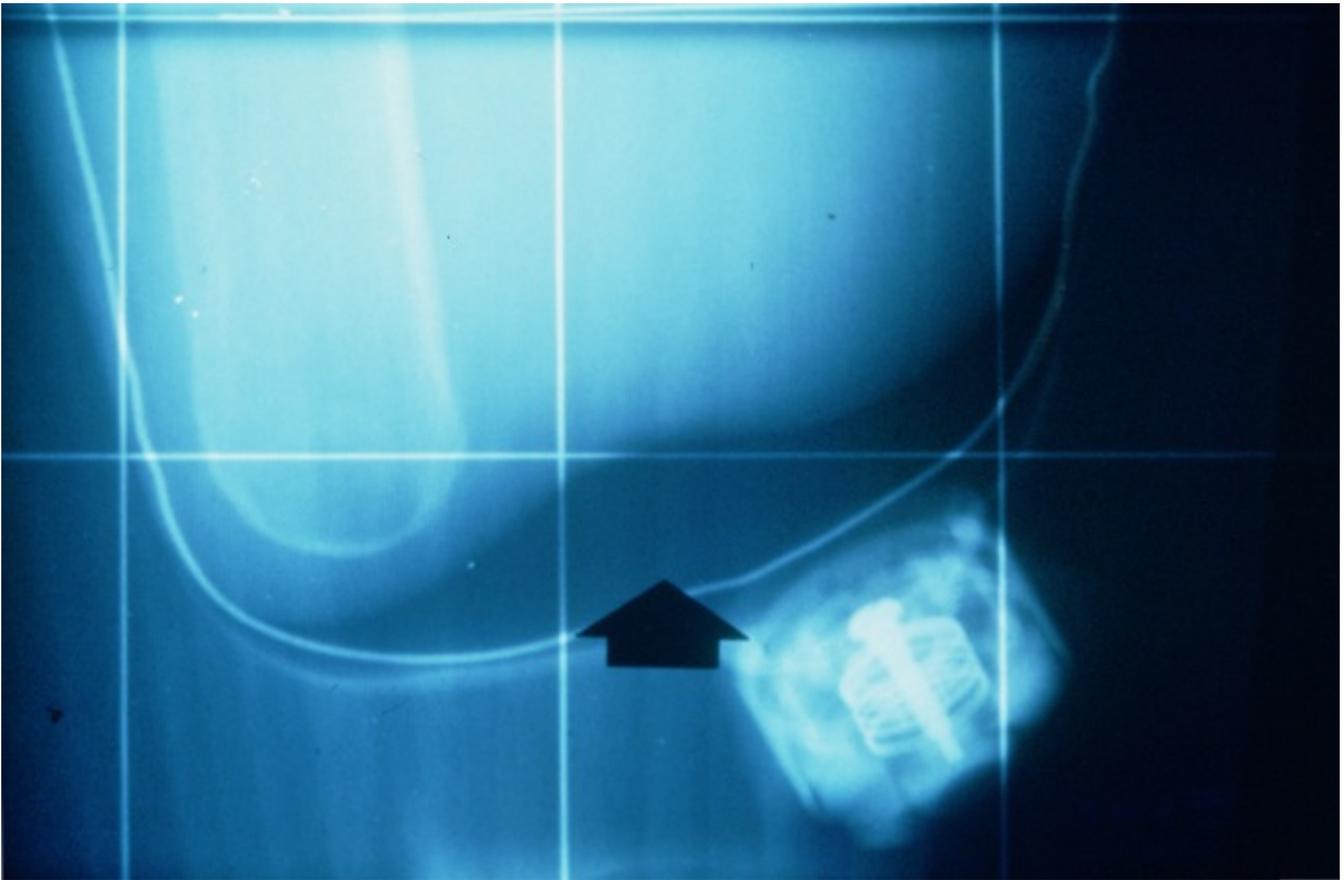
Figure 9

6. Total Contact. Current design concepts require total contact of the stump with the socket. Lack of total contact on x-ray is evidenced by a darkened dead air space as depicted distally in Figure (9).

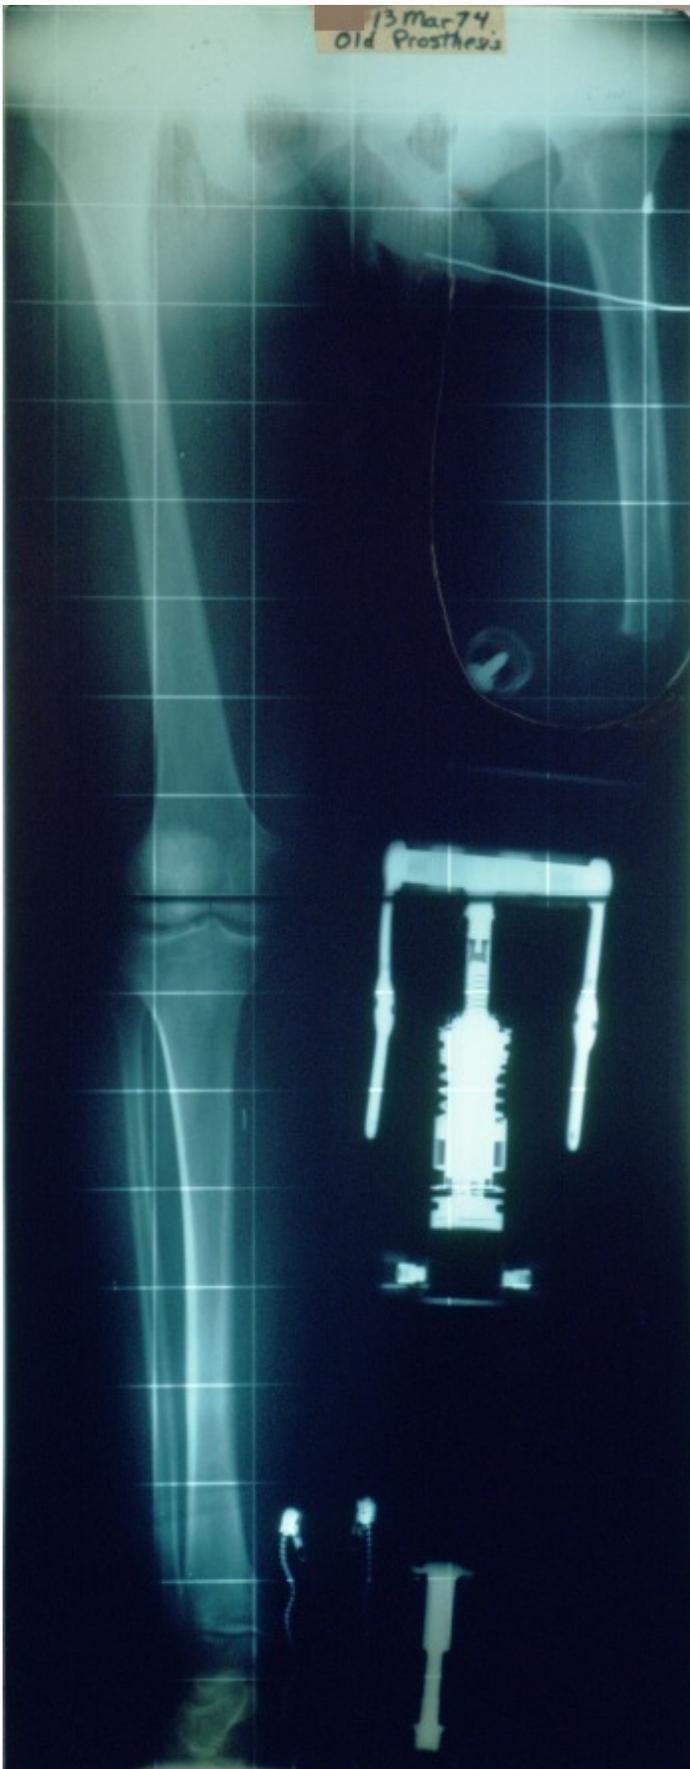
Figure 10

SUMMARY: While several other points were noted on x-ray examination as deviations from traditional alignment criteria, the above six points were found to be the most common. Figure (10) is an x-ray of a patient and his prosthesis that was aligned by conventional criteria. Note the uneven Ischial seat, the abducted posture of the femur, and the tilted knee bolt. The x-ray of the new prosthesis Figure (11) modified as the result of the previous x-ray evaluation demonstrates how improved socket support and mediolateral alignment can be achieved. Note the level seat, the adducted femur, and the level knee bolt.
