The Use of X-Rays and Xerograms in Prosthetics

Thomas P. Haslam, C.P.
Michael T. Wilson, C.P.O.
Martha J. Urlaub, L.P.T.
Roy M. Borrell, M.D.

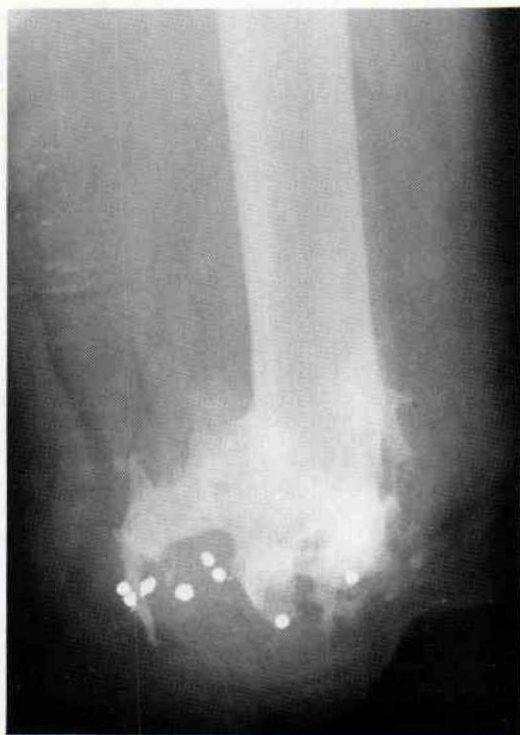
Fig. 2. Conventional x-ray of the distal femur of Mr. C showing calcium formation of buckshot.

ambulation the patient complained of severe cramping and pain on the distal $\frac{1}{3}$ of his residual limb. Upon examination of his residual limb, a firm area of tissue was palpated on the medial distal and posterior distal aspects of his limb. X-rays (Fig. 2) were then taken of his limb which revealed a massive calcium formation on his medial and posterior distal femur. This growth was probably secondary to multiple foreign bodies (buckshot) remaining in the soft tissues.

A clinical decision was made to continue the attempt to fit Mr. C with a total contact suction socket because he had successfully worn one in the past. Mr. C was fit with multiple test sockets with x-rays taken during the fittings, and is now a successful wearer, and has returned to his job as a policeman.

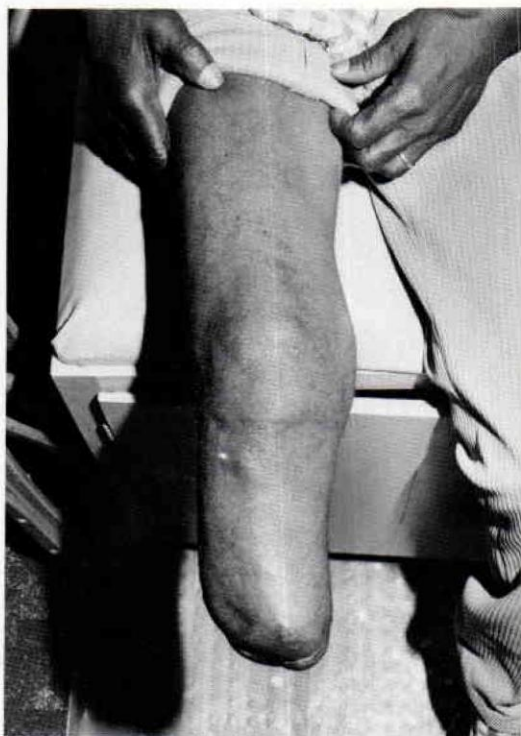
Fig. 3-A. Mr. J presents a normal-appearing below knee amputation.

Mr. J was referred to our facility with a prescription for a below knee prosthesis. Visual inspection (Fig. 3A) noted a well healed, non-edematous below knee amputation with a longitudinal scar along the lateral aspect of his leg. Even though there were no complaints of pain or tenderness, an x-ray (Fig. 3B) revealed two metal plates, one along the lateral aspect of the femur and one along the lateral aspect of the tibia. Several of the plate screws extended into the soft tissues in some weight bearing areas. Also, a butterfly shaped bone fragment was found to be dislodged in the medial tibial condyle area. Mr. J was initially fit with a preparatory prosthesis with gel insert and M.A.A.I.A. [multiple axis audio indicating ankle] (Fig. 4); a double layer of gel was used on the medial aspect of the socket and an M.A.A.I.A. was used to initially limit weight bearing and then

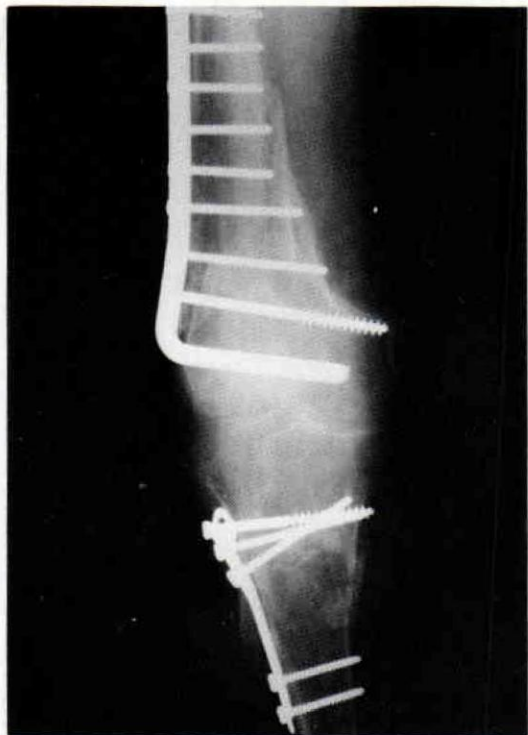
Fig. 3-B. An x-ray revealed femoral and tibial plates with screws extending into weight bearing areas.

slowly progress the patient to a full weight bearing status. This was accomplished in two weeks and, as anticipated, four weeks post fitting, the tibial plate began to loosen and was surgically removed.

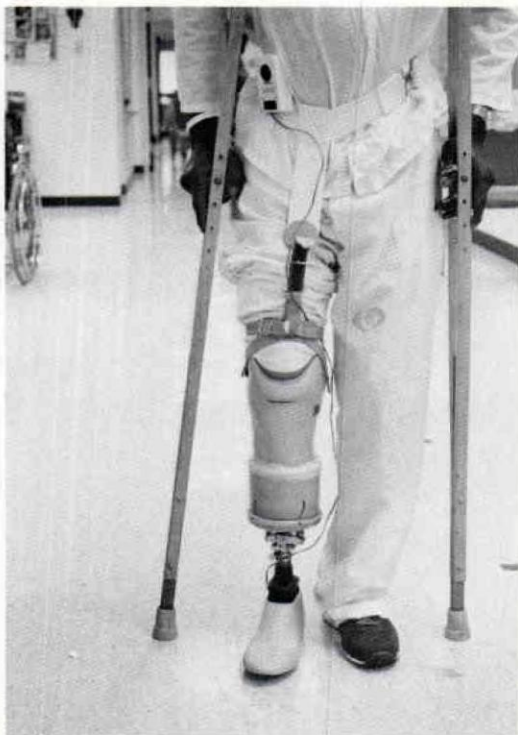
Fig. 4. Patient Mr. J was fit with a gel insert, PTB socket, multiple axis audio indicating ankle, and waist belt. The tibial plate loosened in response to weight bearing and was surgically removed.

The patient is now doing well using a patella tendon bearing prosthesis, gel insert, A.F.P. [adaptive fixation prosthetic] construction and SACH foot. If x-rays were not used to determine this patient's problem, a great amount of time and effort could have been wasted attempting to reduce the pain by different prosthetic modifications.
