Technical Note: A Case Study— Special Choparts Prosthesis with Custom Molded Foot

Robert D. Young, B.S. Ed., C.P.

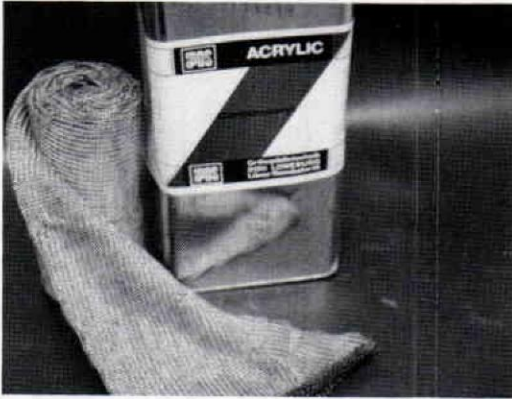
Figure 1. I.P.O.S. Carbonacryl[®] resin and carbon fiber and fiberglass stockinette.

IPOS-Ipocast System® using carbonacryl resin and carbon fiber and fiberglass stockinette (Figure 1) is the material used to add strength without weight or thickness in the socket. A layup of one layer of dacron felt, two layers of the Ipocarbon® stockinette, and four layers of nylglass® stockinette was used. The Ipocarbon® stockinette is coarse textured and black, so the socket was roughed up for good bonding, and two

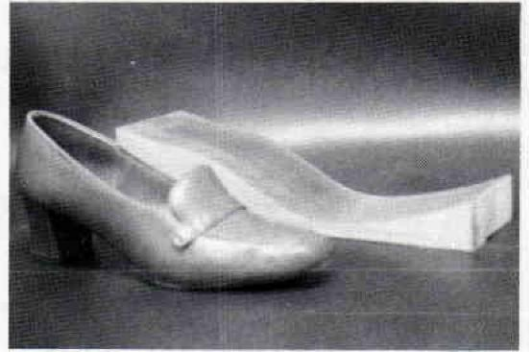
Figure 2. Shoe with custom foot plate.

Since intimate fit in the patient's shoe was a major concern, it was important to make a foot plate that matched the shoe sole contour (Figure 2) of the shoe provided. A partial weight bearing alginate impression of a similar sized-foot was made on the custom foot plate. This impression was then filled and modified by smoothing, filling in the plantar toe spaces and between the toes (Figures 3 & 4), and

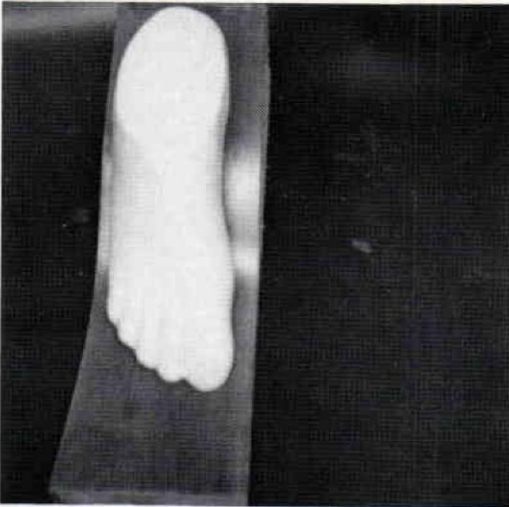
Figure 3. Dorsum of modified foot.

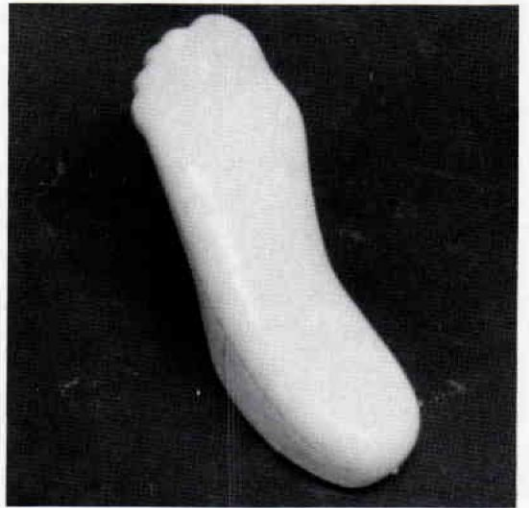
Figure 4. Plantar surface of modified foot.

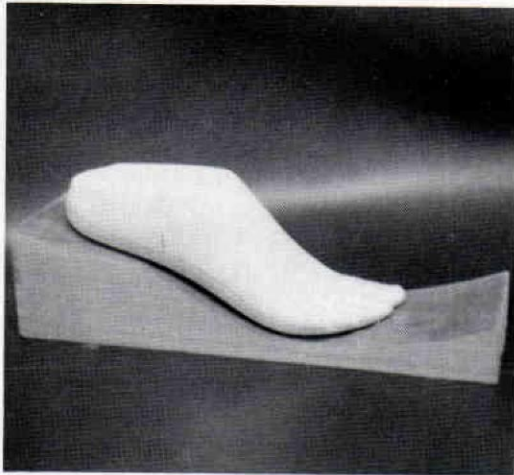
Figure 5. Lateral modified foot.

modifying toe lengths and widths for a better fit in the toe area of the shoe. The modified foot was then allowed to dry and coated with a plastic parting lacquer before making a three-piece mold. The peak width was drawn around the entire foot to locate the trim lines for the mold (Figures 5 & 6).

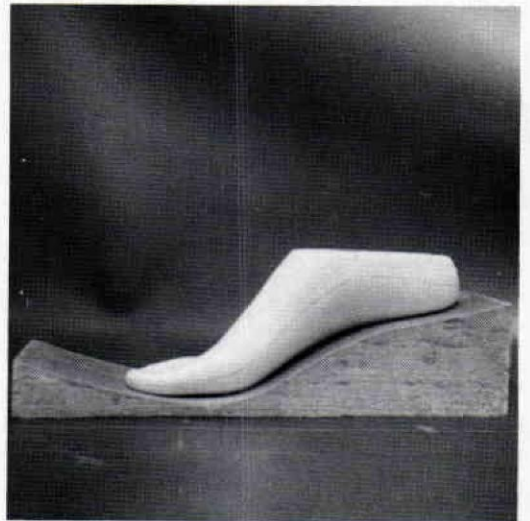
Figure 6. Medial modified foot.

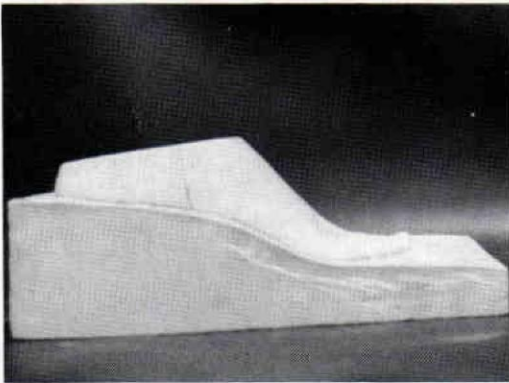
Figure 7. Lateral foot in mold base.

The bottom portion of the mold (Figures 7 & 8) was made first by using a sand casting technique. The modified foot was placed on a platform upside down and sand contoured to the lines drawn around

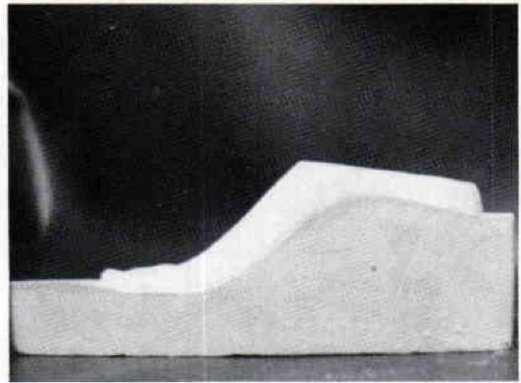
Figure 8. Medial foot in mold base.

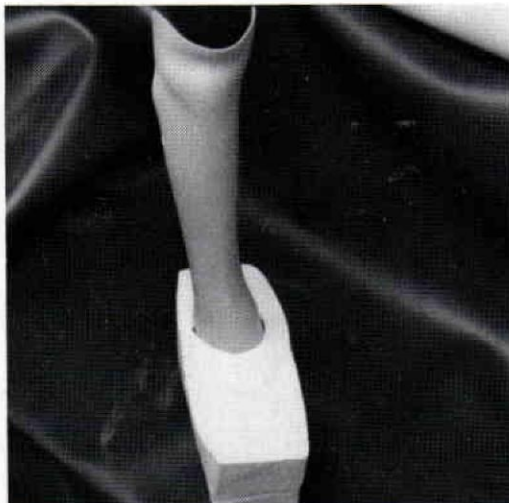
Figure 9. Adduction alignment of socket in mold.

To achieve full functional and cosmetic integrity, the three-piece mold was carved to accept the socket in correct adduction and flexion alignment for the heel height of the shoe provided (Figures 9 & 10). Just

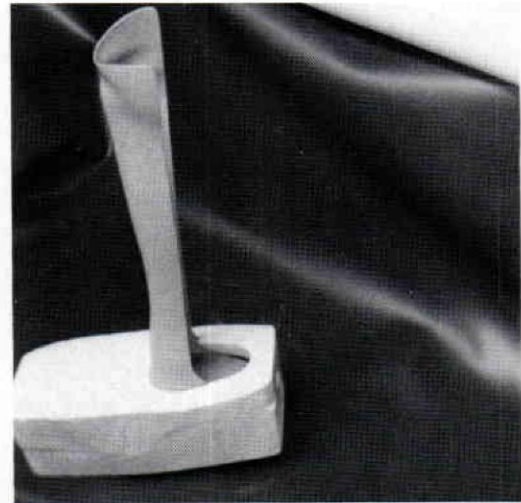
Figure 10. Flexion alignment of socket in mold.

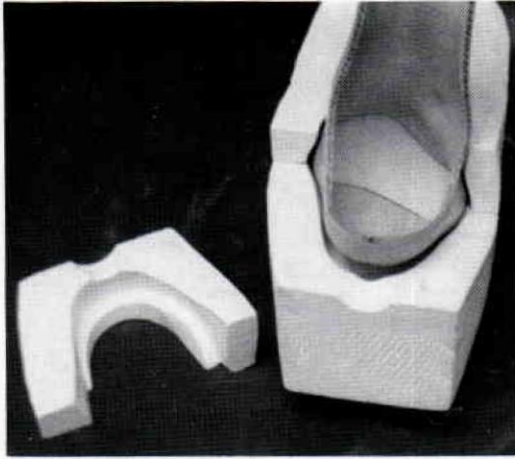
Figure 11. Posterior view—socket in mold.

enough plaster was removed around the sides of the socket to allow the foot to flow into the socket (Figure 11). In order to provide functional stability to the prosthetic foot, a wooden keel was attached to the anterior socket (Figure 12). It was affixed with epoxy and screws extending through from the inside of the socket (Figure 13).

Total weight of the prosthesis including all straps (Figures 23, 24, 25) is 2¼ pounds. Thickness of lamination was kept to a minimum even around the cutout area (Figures 11, 13, 26) because of the extra strength of the carbon acrylic materials in the socket. Taking into consideration the special problems listed in the beginning of the article, the extra time and special mate-

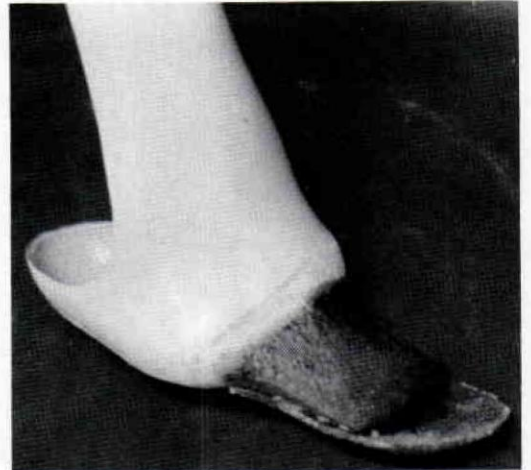
Figure 12. Socket with keel and belting attached.

A piece of belting was attached to the plantar surface of the keel extending into the toe area of the foot (Figure 12). Calthane® foam was used to mold the foot directly into the socket. The Calthane® was poured into the mold through a sprue provided in the heel area of the mold (Figures 14, 15, 16, & 17) at an angle to allow any bubbles to rise into areas of least importance.

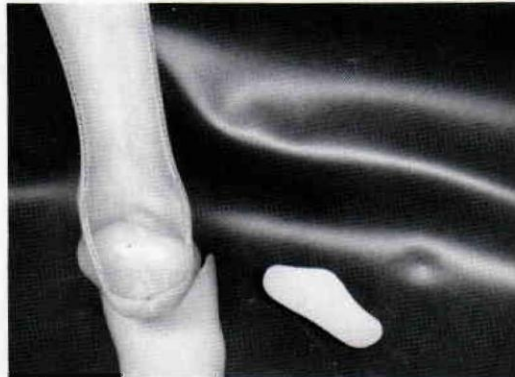
Figure 13. Posterior socket showing screws and P.P.T. pad.

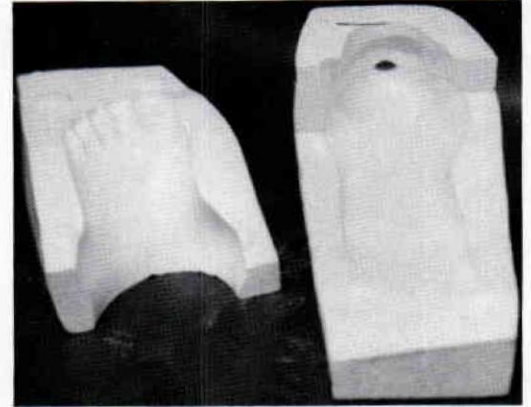
Figure 14. Partially assembled mold.

rials' expense was warranted for this patient (Figures 14 & 27 show relationships between the modified foot and mold sections).

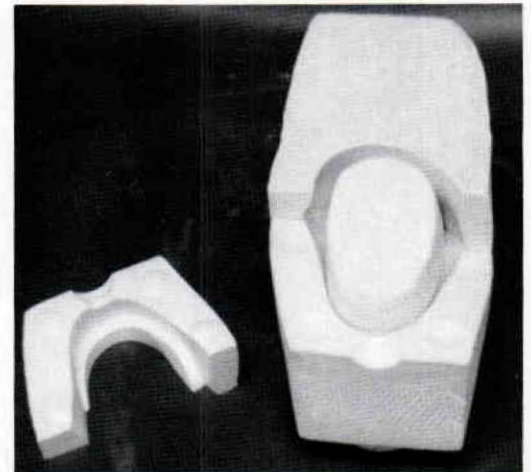
Figure 15. Mold partly assembled over modified foot, showing areas removed to fit socket.

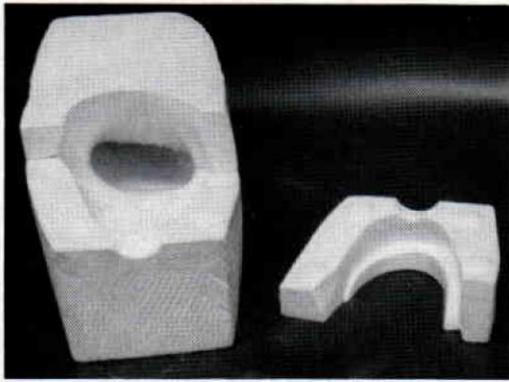
Figure 16. Partially assembled mold.

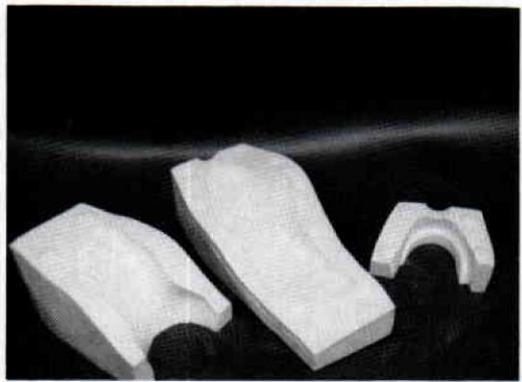
Figure 17. Disassembled three piece mold.

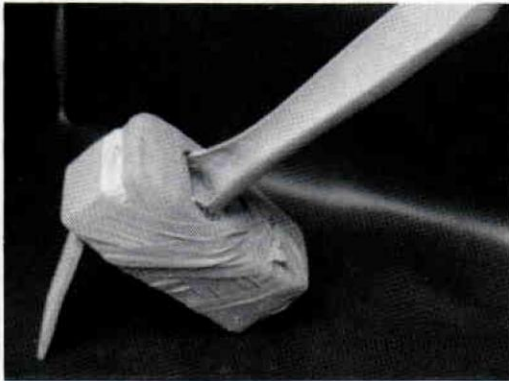
Figure 18. Socket and mold in position for pouring Calthane®.

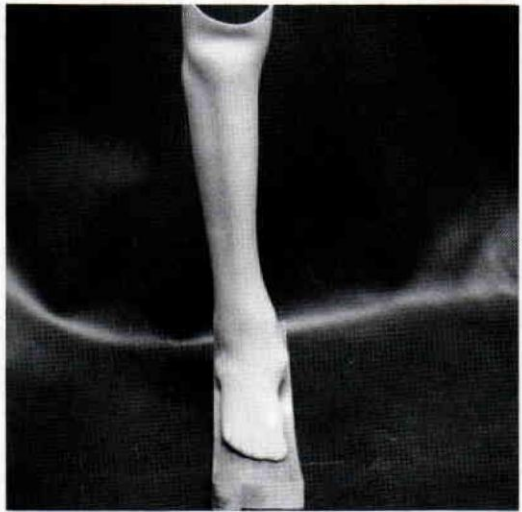
Figure 19. Anterior view of prosthesis.

base of support. The foot is integrated into the overall lines of the socket and doesn't require additional covering to be cosmetically acceptable (Figures 19, 20, 21, 22). The appearance and volume of the foot is closer to normal in the toe area because it was modified from a real foot instead of a prosthetic foot.

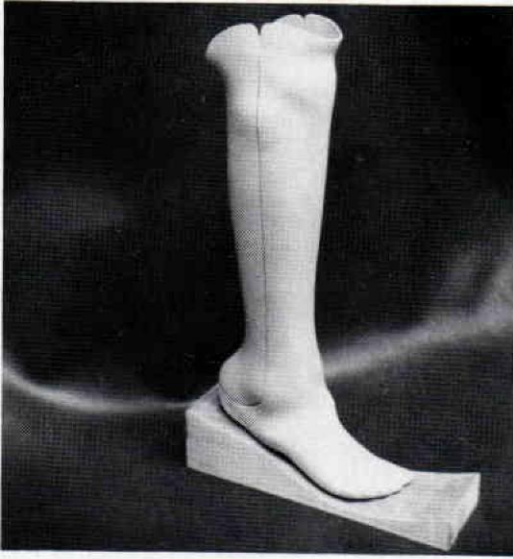
Figure 20. Lateral view of prosthesis.

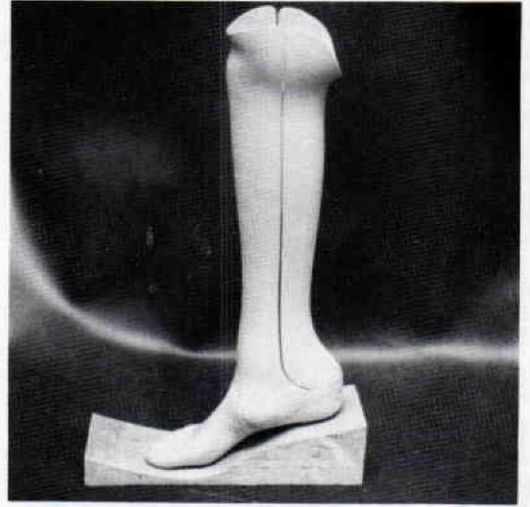
Figure 21. Medial view of prosthesis.

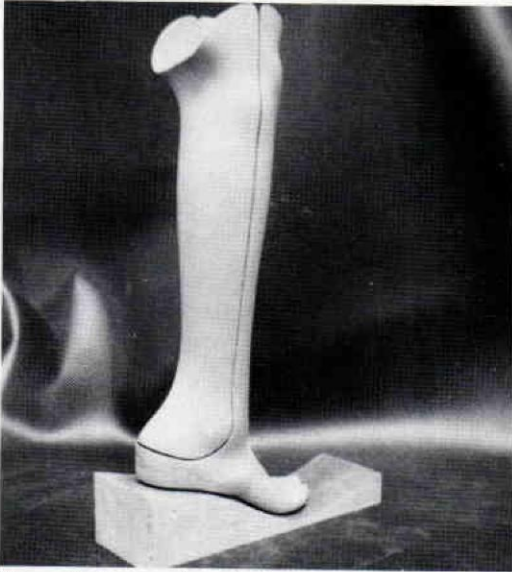
Figure 22. Postero-lateral view of prosthesis.

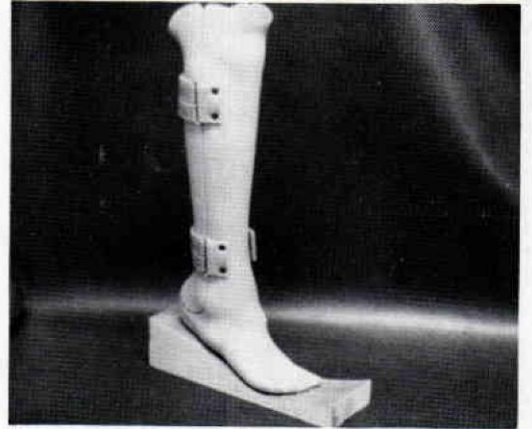
Figure 23. Antero-lateral view of prosthesis complete with straps.

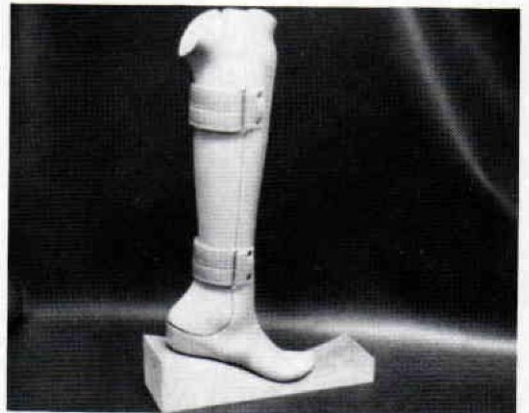
Figure 24. Postero-lateral view of prosthesis complete with straps.

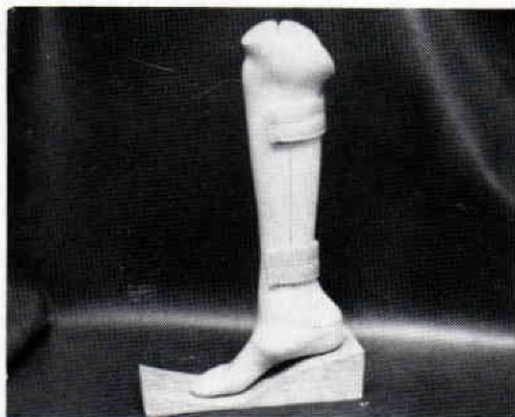
Figure 25. Medial view of prosthesis complete with straps.

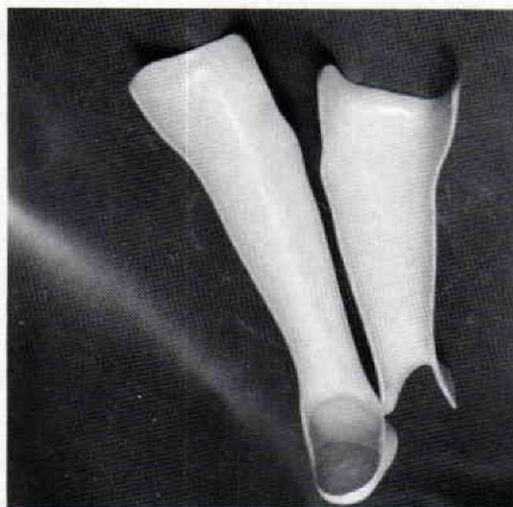
Figure 26. Socket halves.

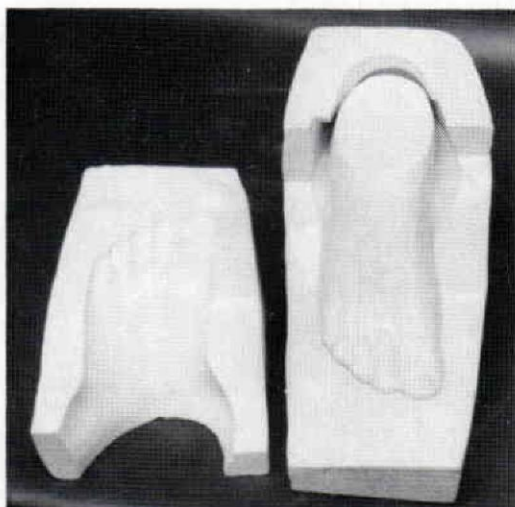
Figure 27. Partially assembled mold with modified foot in place.
