X-Ray Evaluation of the Above Knee Socket;
A Supplement to Standard Check-out Procedures

Capt. C. James Scanlon, AMSC
Lt. Col. Bob Doctor, AMSC

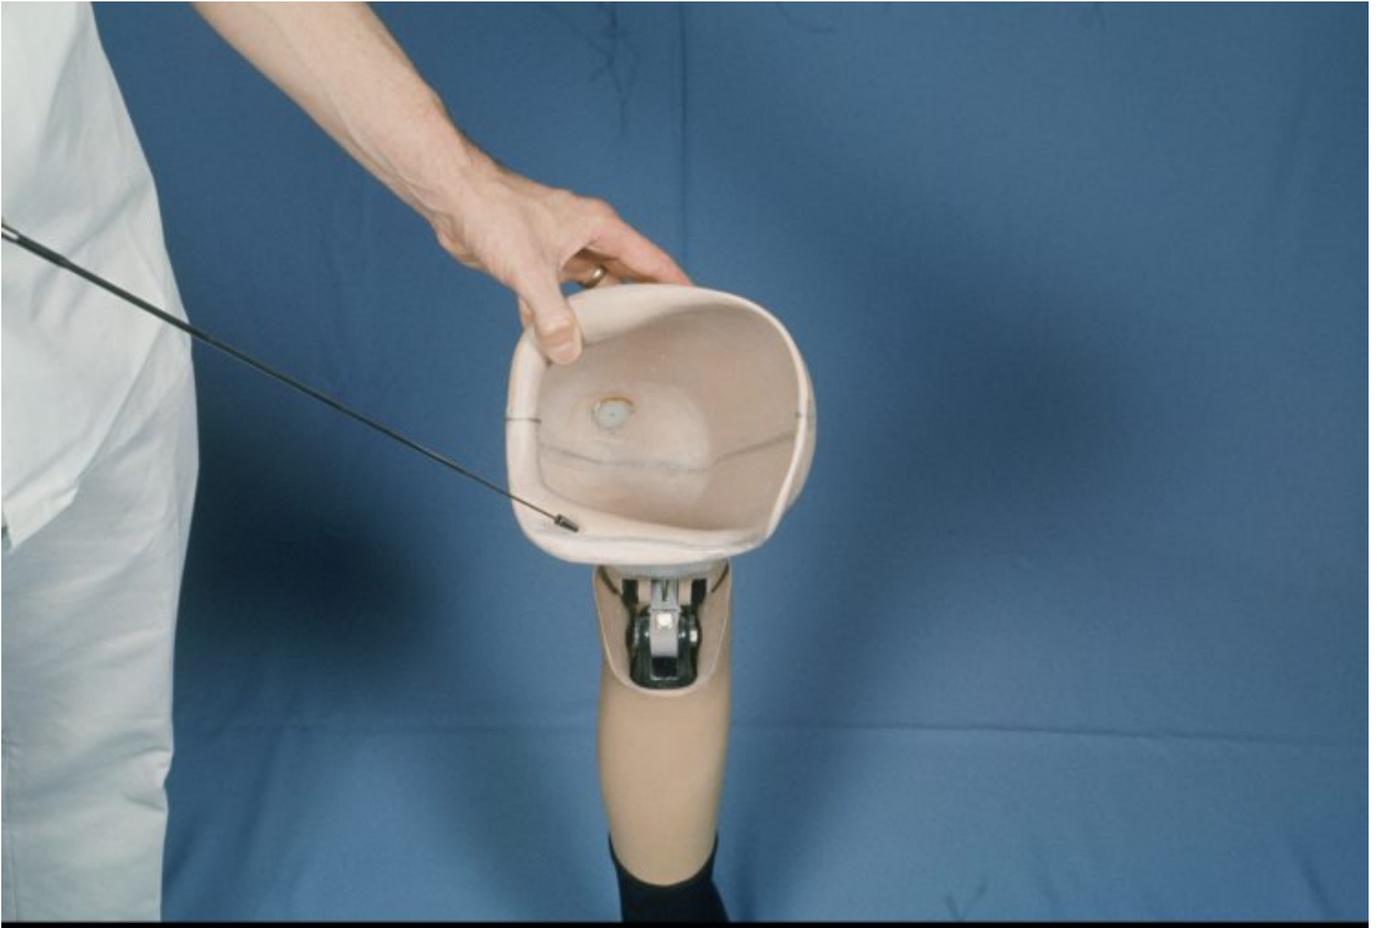
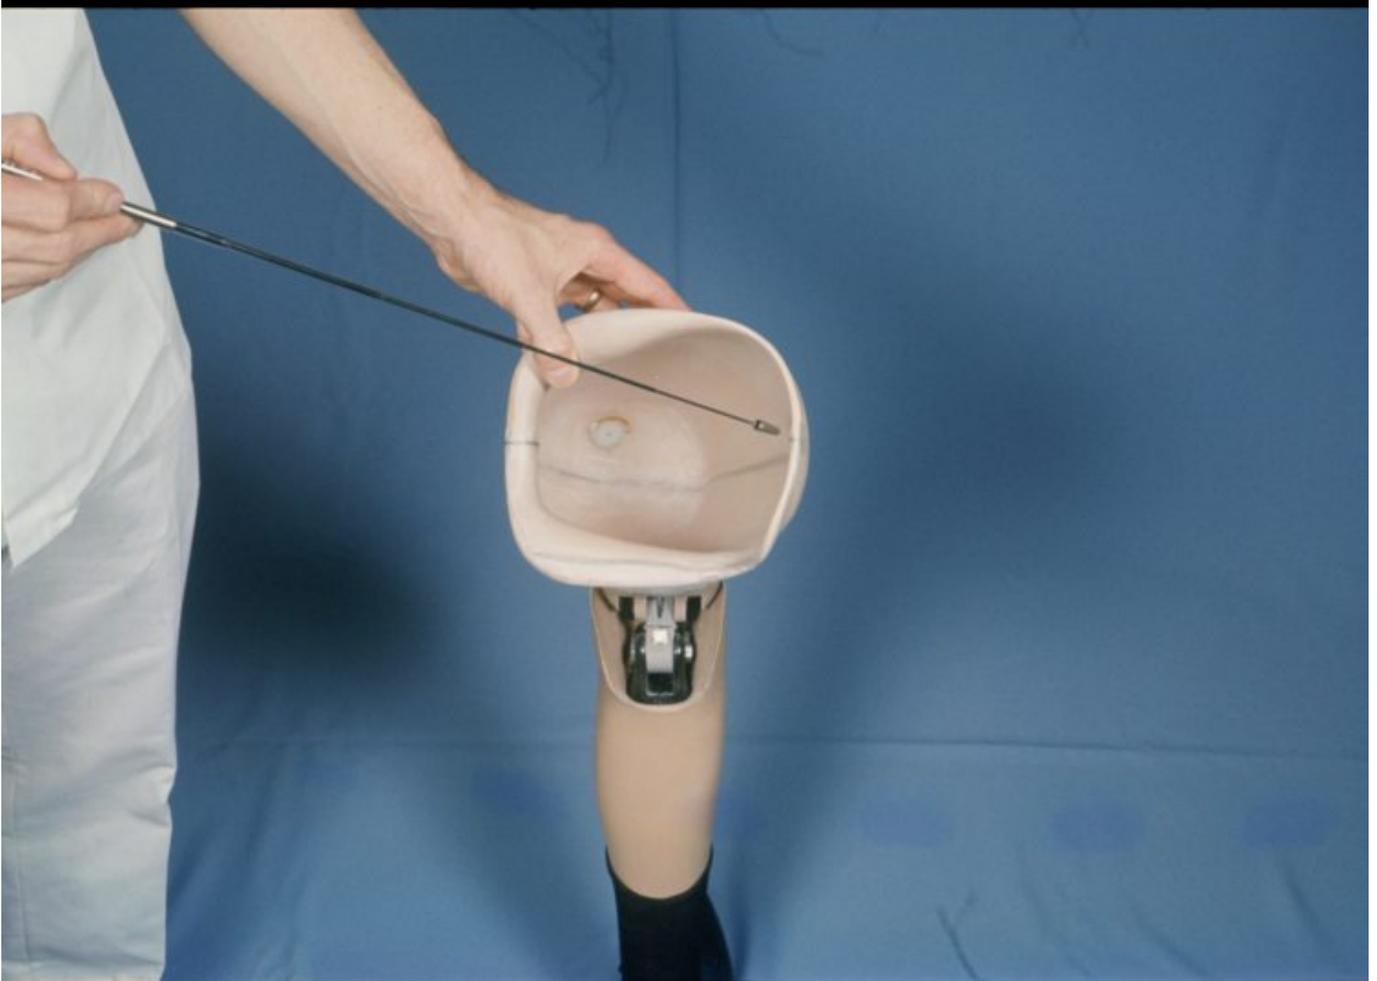
Procedure: The procedure followed in this X-ray checkout is as follows: Prior to X-ray, a small solder wire is taped to the superior surface of the posterior brim of the prosthesis and a second wire is taped inside the socket in the center of the medial wall down to the distal end and back up the lateral wall. These wires help visualize the stump-socket interface on the X-ray (Fig 1). The patient then applies the prosthesis.

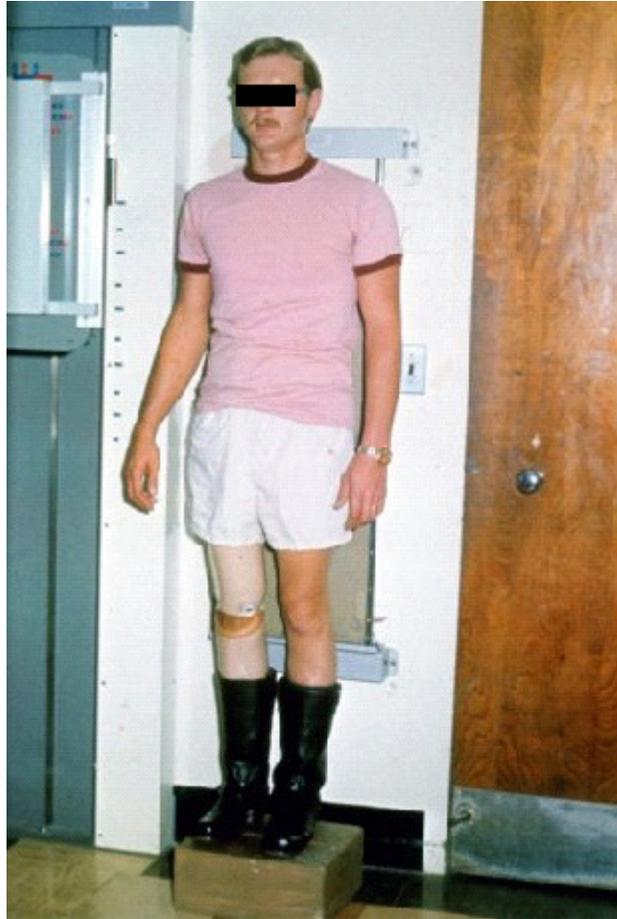
Figure 2

An anterior - posterior x-ray projection of the patients' pelvis, femurs, and knees is taken utilizing a 14 inch by 36 inch x-ray cassette with a 6 to 1 grid ratio. The x-ray is taken at a 72 inch tube film distance with the central ray focused at the level of the posterior brim of the prosthesis. The amputee stands facing the machine with his feet spaced 2 inches apart, weight borne equally on both lower extremities, and void of anterior posterior pelvic rotation. (Fig 2)

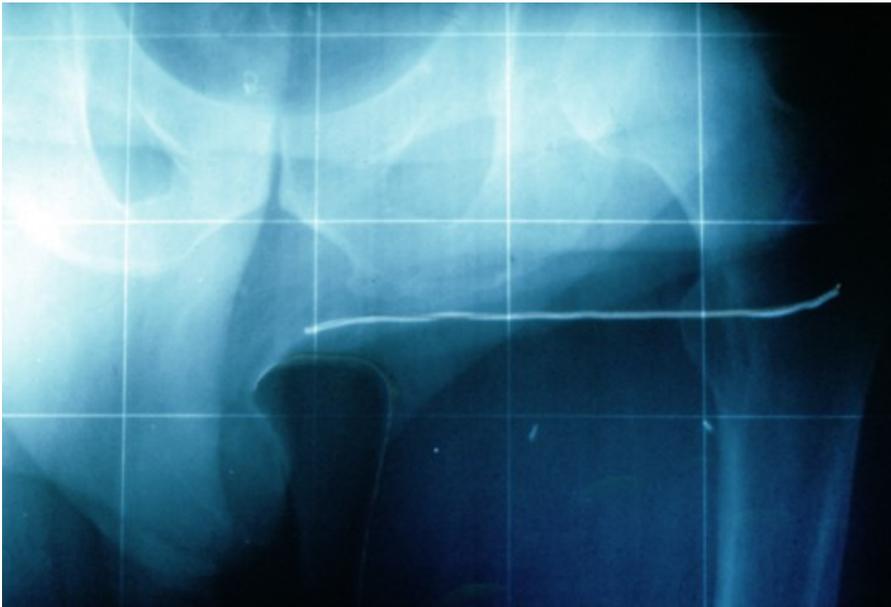
Figure 7

5. Ischial Seat. The actual position of the Ischial tuberosity on the posterior brim of the prosthesis is yet another difficult point to pin point clinically. The usual standard is for the tuberosity of the ischium to rest directly on a level posterior brim approximately one inch from the medial wall as noted in Figure (7). Figure (8) shows a variety of different deviations found thru x-ray examination.
