Follow-up Experience with an Orthosis Combining the Supracondylar Knee Orthosis and the Spiral Orthosis

by Thomas A. Martin, CPO*

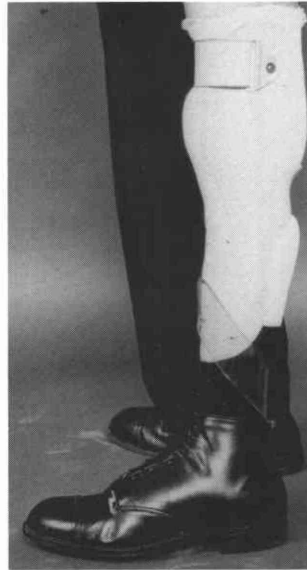
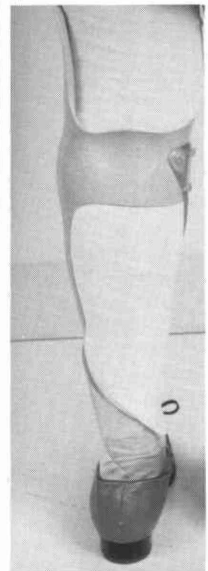
Side and posterior views of orthoses similar to that described by Mr. Martin in his article. (The photographs supplied by Mr. Martin proved to be unusable.) These are supplied courtesy of H. Richard Lehneis, Ph.D., CPO.

Possibly being more persistent than intelligent, we proceeded. We were unsuccessful in our attempts on three separate occasions in reapplying the spiral type AFO. We finally tried #4134-30 percent and #4110-70 percent polyester resin, laminated with four layers of fiberglass and two layers of glass, and used 1/16" polypropylene welding rods that ran the entire length, one inch apart.

Using the old holes of the SKO, we were unsuccessful in obtaining satisfactory alignment when attaching the spiral unit. Therefore we were forced to tape the two units together until we had a compatible arrangement. Once the two components were riveted together, she had some problems in gait, especially between heel strike and foot flat, clearly indicating that the SKO was affecting the knee by not allowing it to go into recurvatum.
